BOWEN FARMHOUSE

INVENTORY FORM FOR STATE HISTORIC SITES SURVEY

Bowen Farmhouse

ADDENDUM TO "BOWEN FARMHOUSE"

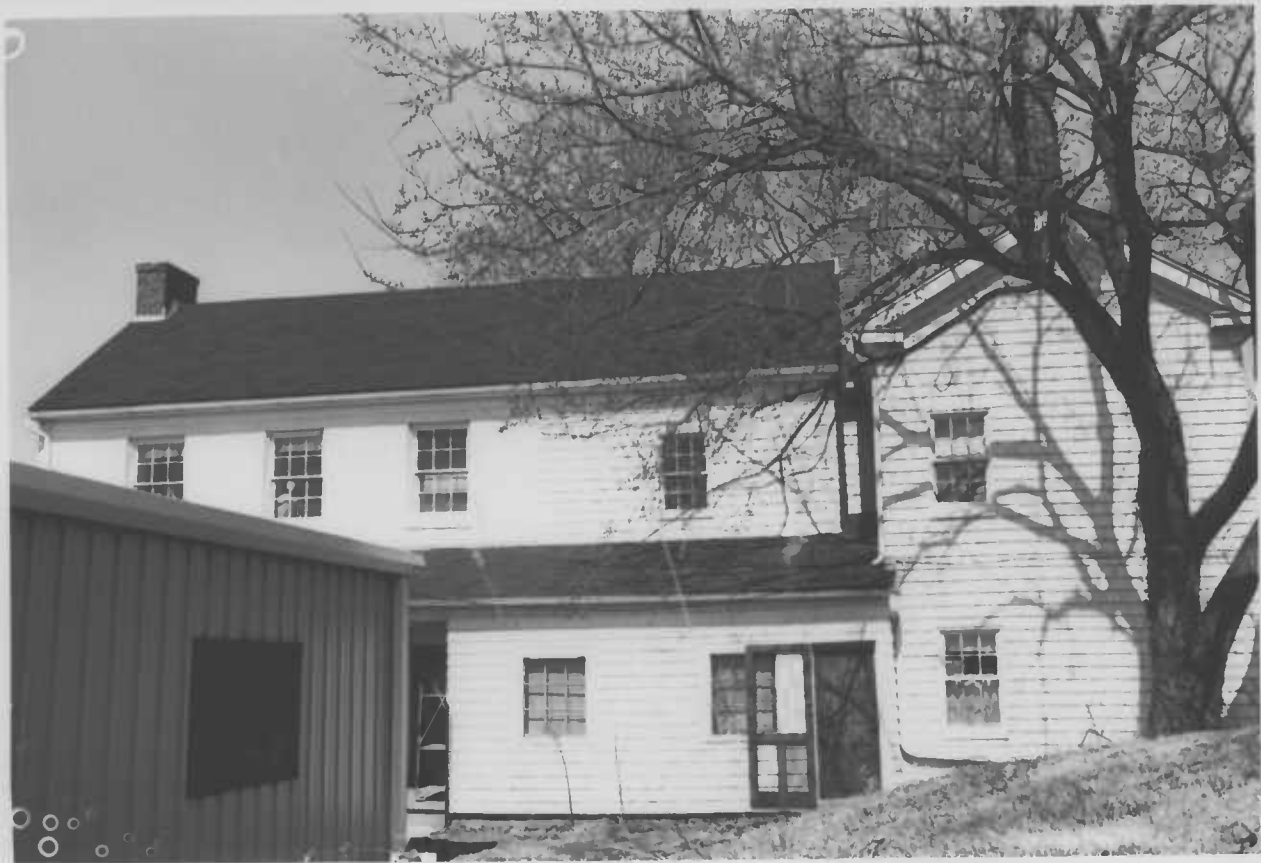
BOWEN FARMHOUSE
N. FACADE

The north facade of this building is suggestive of the same problems encountered in arriving at a solution for the main facade at George Washington's "Mt. Vernon." In that building the frame of an older and smaller farmhouse served as the core onto which many additions were made. The final attempt at bringing all of these parts together in a unified facade by feigning centralization was only mildly successful. A closer look at Mt. Vernon always reveals an off center central entrance beneath the central pediment, an awkward relationship contrary to the Georgian value of symmetry. From a distance the Bowen farmhouse appears to be an integrated structure and a centrally placed Victorian cross-gable helps. When up close to the north facade, however, one sees that the entrance is not central and two types of clapboards, shingles, and stucco covered stone define various sections that are anything but unified. It is a most interesting study in vernacular architecture.

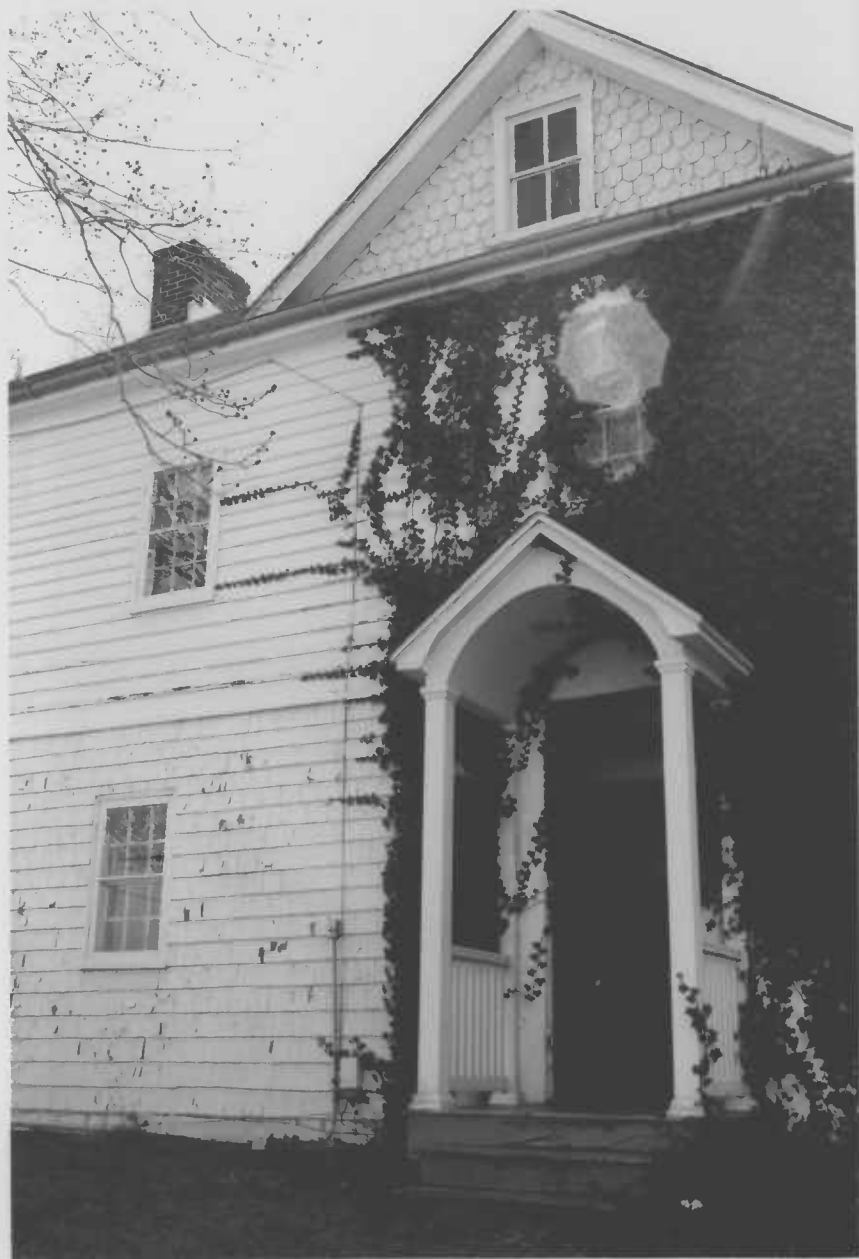
BOWEN FARMHOUSE
N. FACADE
DETAIL

In opening the north wall an approximate 4 by 6 foot area was chosen in the northeast corner of section A where it abuts section B. It was felt that a single opening in this area could reveal the most about how the two sections relate to each other, it might possibly shed light on the problematical chimney, and in exposing the plate log of A tell something of the original height of that section. With regard to this latter question not all of our hopes were realized but the opening at this point did prove fruitful.

It was observed that there are at present two layers of siding and each layer is identical on both A and B. Beneath the outer wooden shingles is a layer of beaded ship-lap weatherboards. These boards were apparently removed from their original position and reattached, butt-joined in order to act as a smooth surface for attaching the shingles. The weatherboards are attached with cut nails and some boards straddle both sections. The size of the boards and the decorative bead suggest that they are early, however, that they are identical on both sections suggests that they may not be the original siding of A.

Having fully opened this part of the oldest part of the farmhouse where posts and plates meet there was dramatic evidence that a lighter framed building (section B) butts up against an earlier post-and-beam structure (section A). The ends of beaded ship-lap siding could be seen that once covered section A's east wall.

The top of an $8\frac{1}{4}$ by $6\frac{1}{2}$ inch corner post could be seen as could a plate measuring 5 inches deep and $6\frac{3}{4}$ inches wide. Both pieces are hewn, appear to be oak, and are joined via mortise-tenon-and-trunnel (one inch). An angle brace could be seen at the bottom of the frame joining the corner post $3\frac{1}{2}$ feet below the plate and joining the sill approximately 5 feet West of the post. This sill may be a replacement. A non-functional nail with hammered point and wrought head was pulled from the plate; it may have affixed earlier siding.

Mortised into the plate are roughly finished studs that are $3\frac{1}{2}$ inches wide and $2\frac{1}{2}$ inches thick. They are set flush to the outer edge of the plate. Attached to the inside surface of these thin studs are riven laths. The lath nails are wrought. A $\frac{1}{2}$ inch of brownish plaster containing coarse hair and bits of shell was pressed into the lathing. Three inches further into the wall is another system of studs with laths and plaster, the back of which can be seen in photos "A through F". In photo "F" the earliest wall can be seen on the right side of the newer stud and the newer laths on the left. The "newer" laths, however, are also riven and can be seen as early.
